Contract #: 04-0120F4Cty: SF/ALA Rte: 80 PM: 13.2/13.9File #: 99.28**WELDING INSPECTION REPORT****Resident Engineer:** Casey, William**Address:** 333 Burma Road**City:** Oakland, CA 94607**Report No:** WIR-027100**Date Inspected:** 25-Jan-2012**Project Name:** SAS Superstructure**OSM Arrival Time:** 700**Prime Contractor:** American Bridge/Fluor Enterprises, a JV**OSM Departure Time:** 1530**Contractor:** L & M Industrial Fabricators**Location:** Tangent, Oregon**CWI Name:** Tom Dreyer**CWI Present:** Yes No**Inspected CWI report:** Yes No N/A**Rod Oven in Use:** Yes No N/A**Electrode to specification:** Yes No N/A**Weld Procedures Followed:** Yes No N/A**Qualified Welders:** Yes No N/A**Verified Joint Fit-up:** Yes No N/A**Approved Drawings:** Yes No N/A**Approved WPS:** Yes No N/A**Delayed / Cancelled:** Yes No N/A**Bridge No:** 34-0006**Component:** Tower Head Parapet**Summary of Items Observed:**

CCO: 196 - Description: Construct parapet walls at the Tower Heads

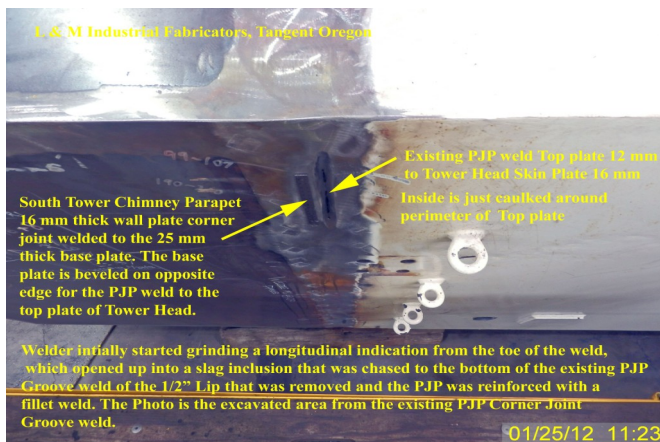
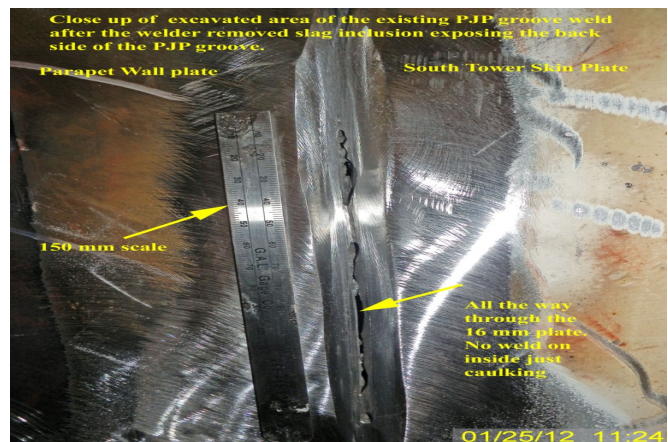
This QA Inspector observed L & M welder Otis Smith (Welder ID #19) performing the grinding operation to remove a MT transverse linear indication detected on the surface at "Y" location (1081) mm of the PJP corner joint groove weld of parapet wall base plate-(A5a) to Tower Head top plate. The welder was preparing the excavated area for welding and the welder informed this QA Inspector that after removal of the transverse linear indication another indication appeared visually that was located in the existing PJP corner joint groove weld connecting the Tower Head top plate to the Tower Skin Plate. The indication visibly detected appeared to be a slag inclusion running longitudinally to the PJP groove weld and was present for the full depth of the (9) mm PJP groove weld. After further grinding, the weld metal was ground too thin and exposed the back side of the PJP groove weld. The welder informed QC Inspector Mr. Tom Dreyer who informed this QA Inspector that he would notify L & M Industrial Fabricators' Client Finnoe Design, Inc. of the findings and wait for Mr. Ben Finnoe to contact ABF representatives for disposition into 1)- repairing the MT longitudinal linear indications being detected in the existing PJP groove weld connecting the Tower Head top plate to the Skin Plate and 2)- consider proposing to add a reinforcement weld on the back side of the existing PJP groove weld.
